Technical Study of collision protection for bus drivers

Development of new solution trends for collision
protection

Manuel Laso, Tor-Olav Nævestad

2096/2025

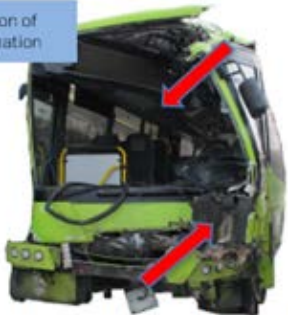
Driver deceased (intrusion of structure)

Figure 2: Damage to the front of the eastbound bus. Photo: AIBN

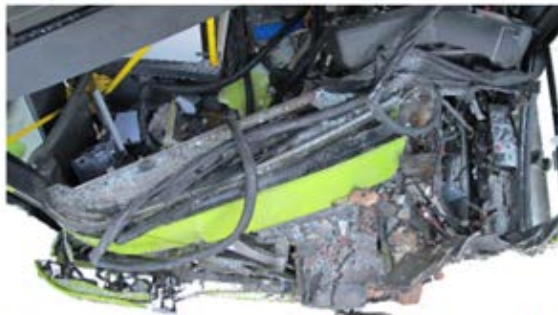
Direction of deformation

Figure 3: Deformations of the driver's cab in the eastbound bus, seen from above. Photo: AIBN

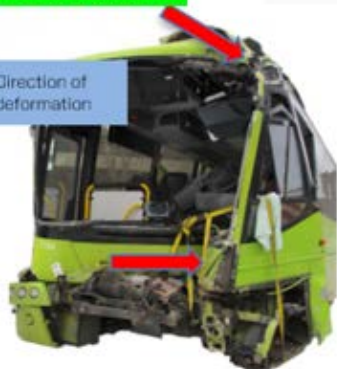
Driver injured

Figure 4: Damage to the front of the westbound bus. Photo: AIBN

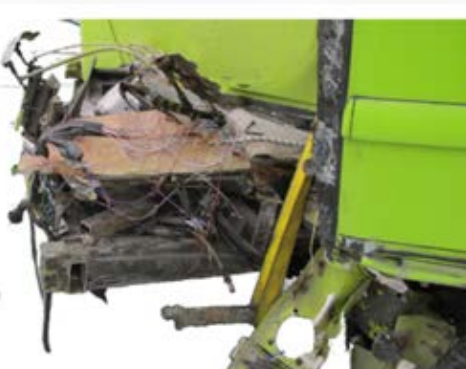
Figure 5: Cross-beam severed on the left-hand side, seen from the side. Photo: AIBN

In the accident reports and the graphical documentation of the vehicle conditions, structural failures that led to the drivers' death and injuries can be observed. The main structural intrusion is due to the penetration of the A-pillar into the impacted bus, causing the structure to collapse and, consequently, reducing the driver's survival space. In this case, the bus coming from the west intrudes upon the one coming from the east, which is the most affected. The loading line on the A-pillar is notable in the accident, where the upper joint of one pillar penetrates into the bus, while the structure of the other pillar pushes outward, creating opposite deformation profiles. This event effectively isolates the impact conditions, as it involves two identical vehicles colliding at the same speed, excluding several variables from the equation.

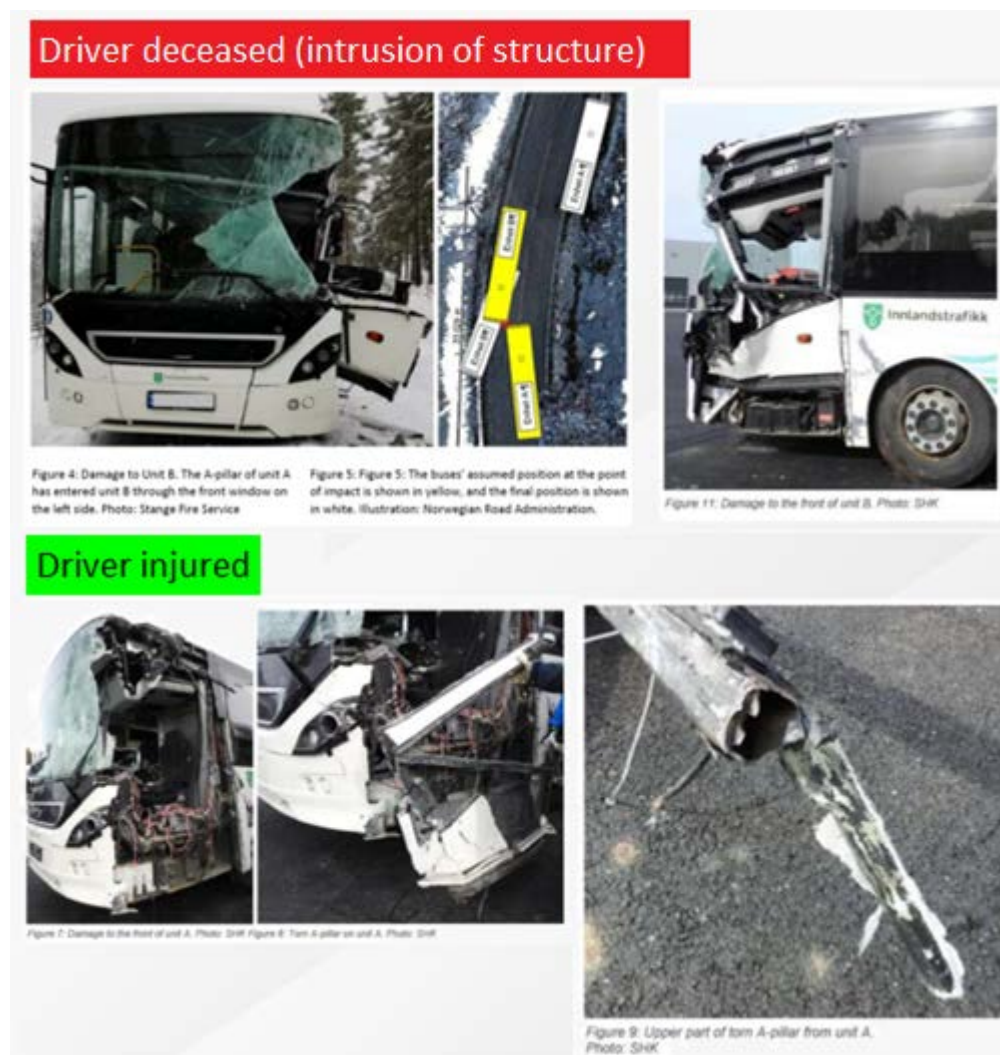
The collision primarily involved the left front corners of both buses, causing significant structural damage, particularly in the driver's cabin area. The A-pillar of the northbound bus intruded into the driver's compartment of the other bus, resulting in fatal injuries for the southbound bus driver despite the relatively low speeds. The central section of the vehicles was almost entirely uninvolved in the impact, meaning that all the collision energy was concentrated on the A-pillar of the first arc. As in previous cases, one structure was torn and penetrated, while the other collapsed inward. However, in this instance, the minor overlap allowed the vehicles to keep moving forward.

Figure 1.4: Status of buses after the crash [2]

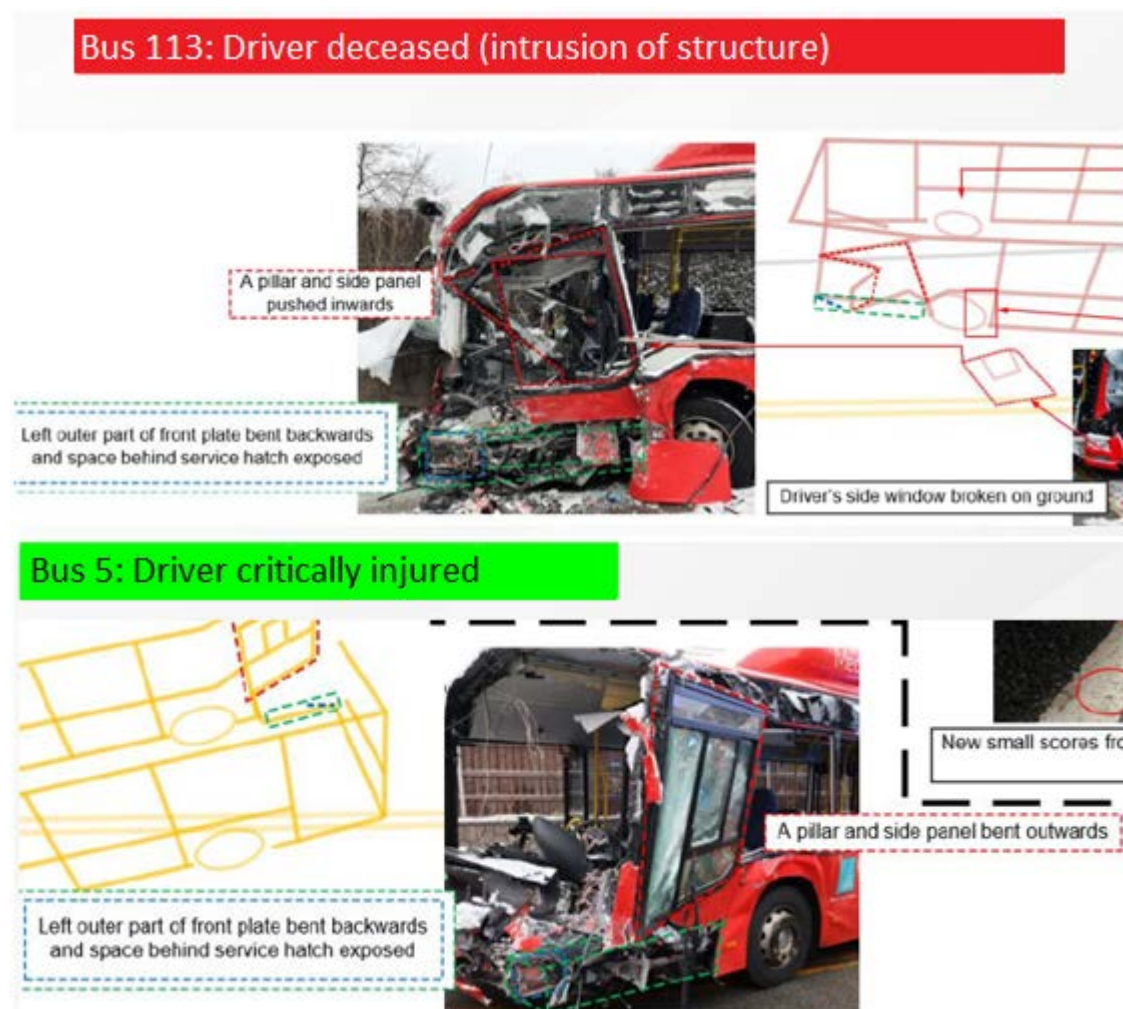
The structural analysis of this event suggests conclusions very similar to those of its predecessors. The report indicates a structural collapse of the A-pillar and an opening of the side structures on both buses, causing intrusion and reducing the survival space to zero for the bus that ended up underneath. In this collision, the seat of the deceased driver was completely displaced from its original position, while the other driver's seat remained in place.

Figure 1.6: Status of buses after the crash [3]

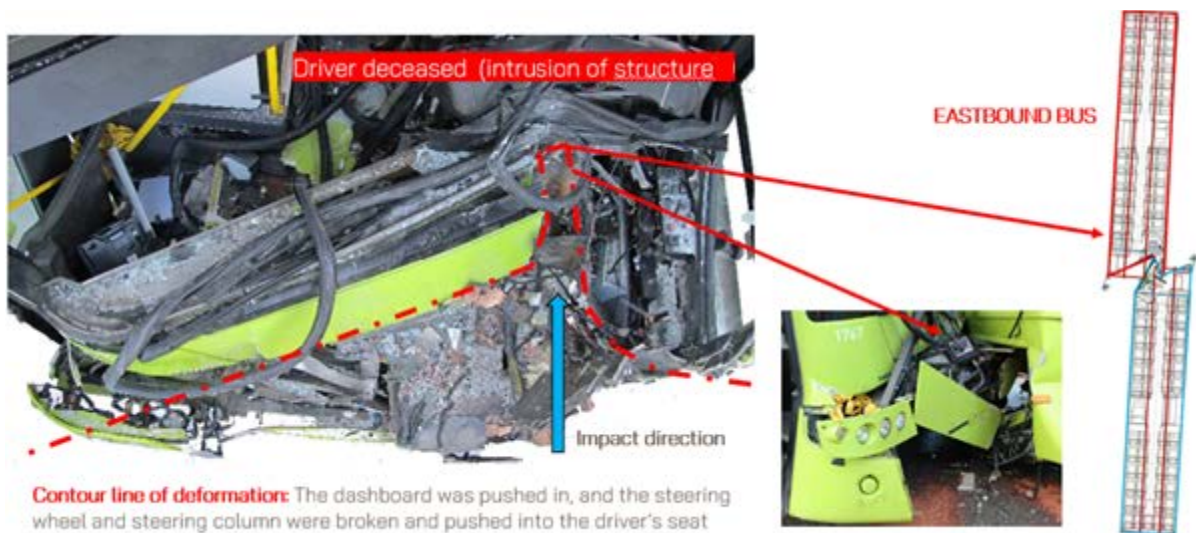
Figure 1.8: Severe intrusion after the crash [1]

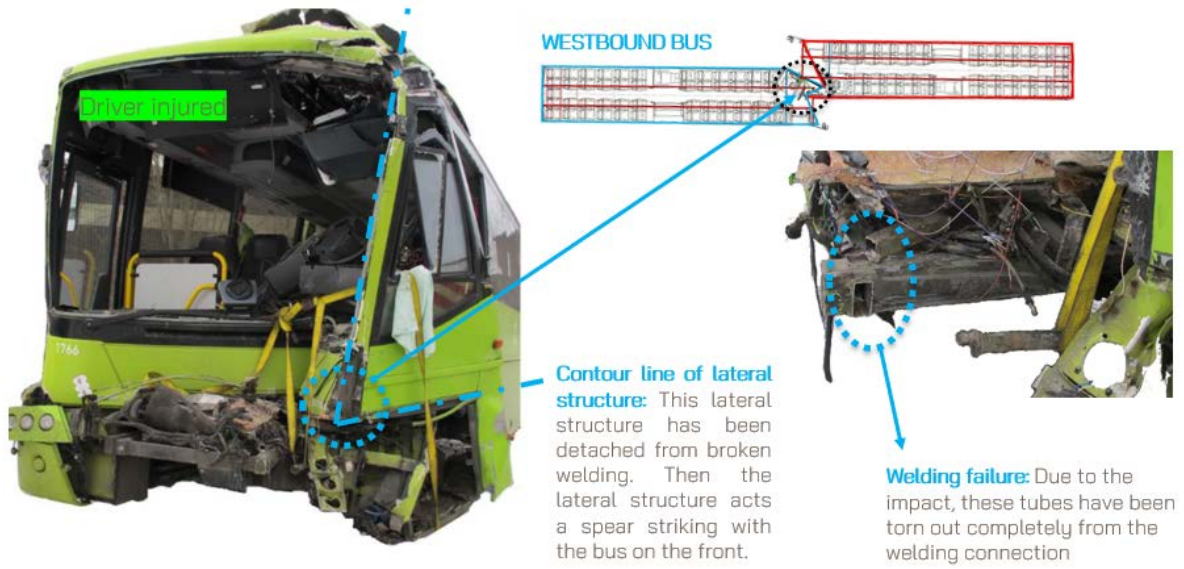
Figure 1.9: Structural status after crash [1]

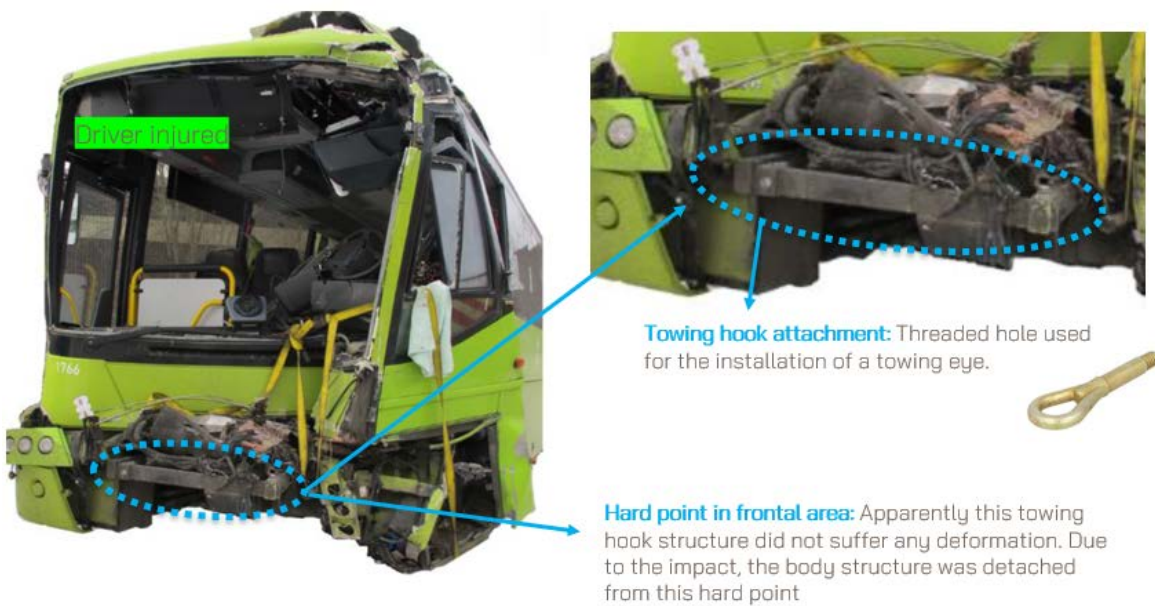
Figure 1.10: Hard point in front area, towing hook [1]

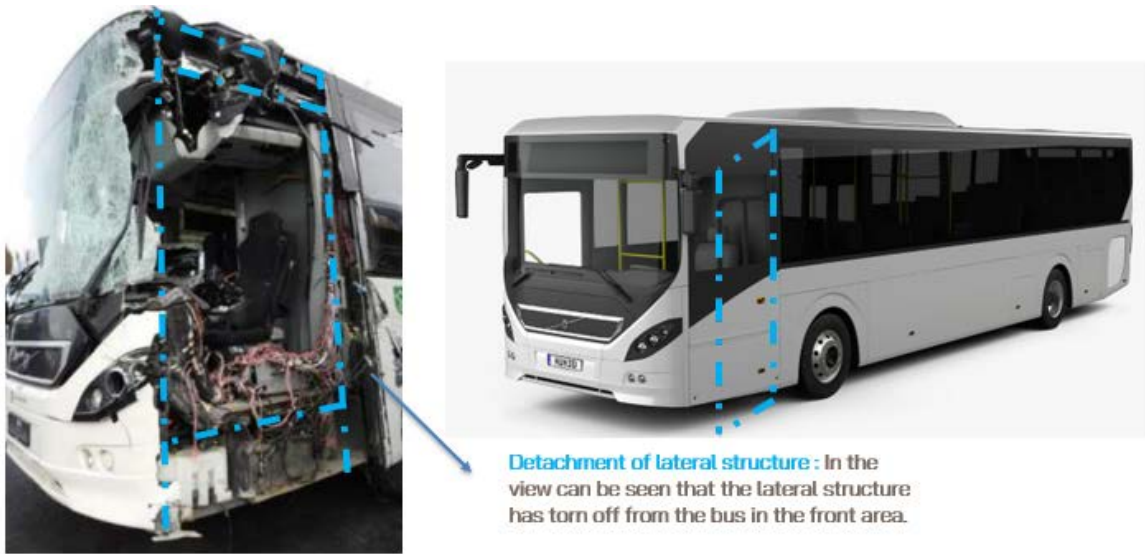
Figure 1.11: Structural status after the crash [2]

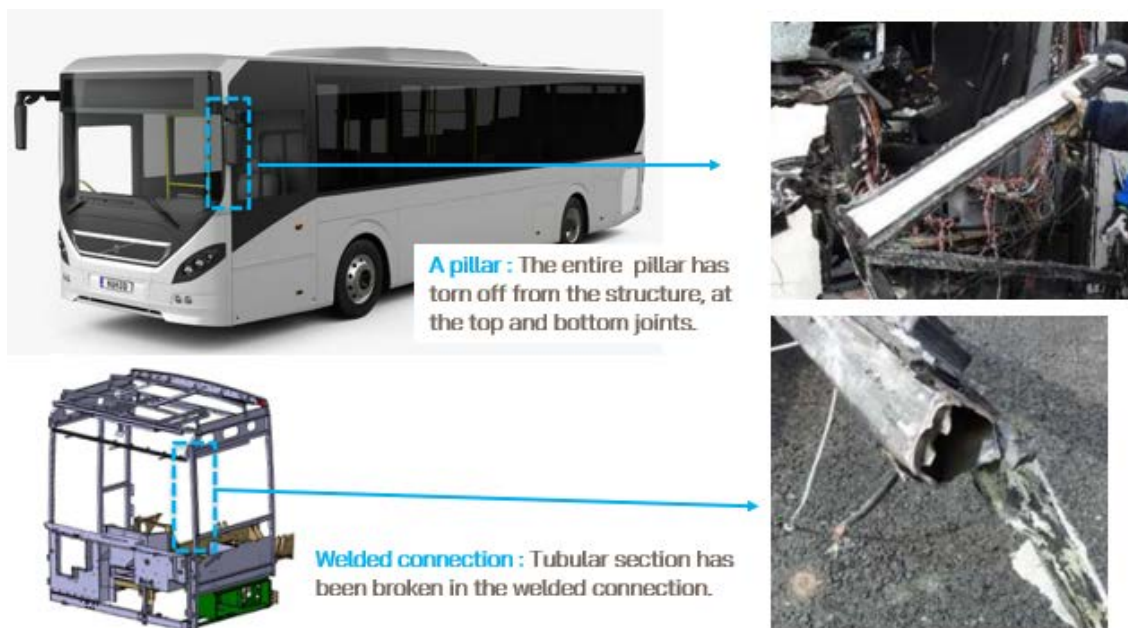
Figure 1.12: Structural status after the crash [2]

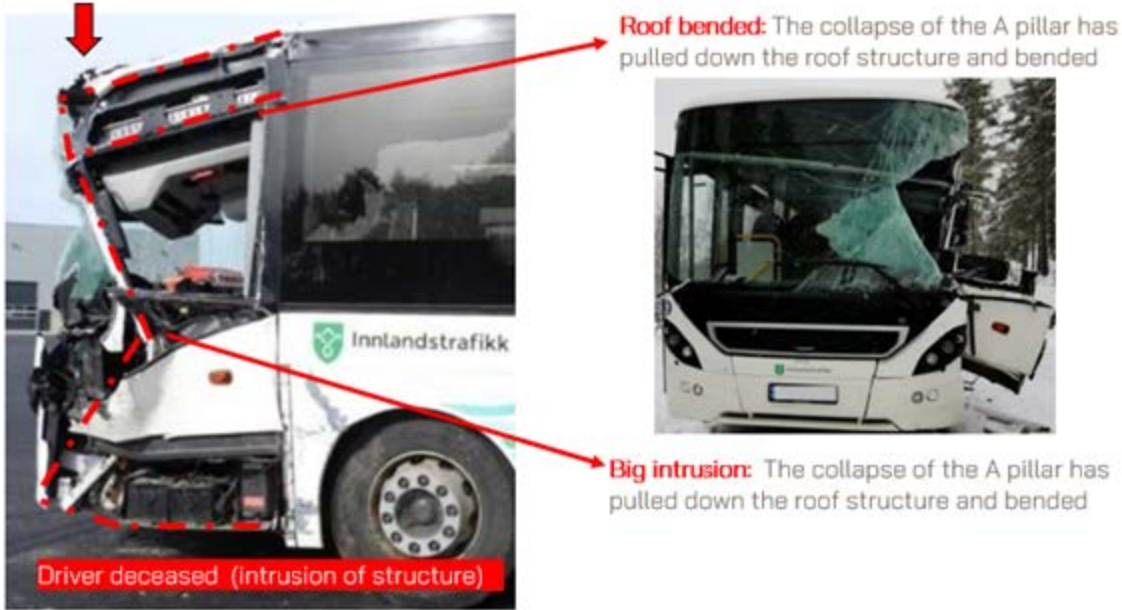
Figure 1.13: Structural status after the crash [2]

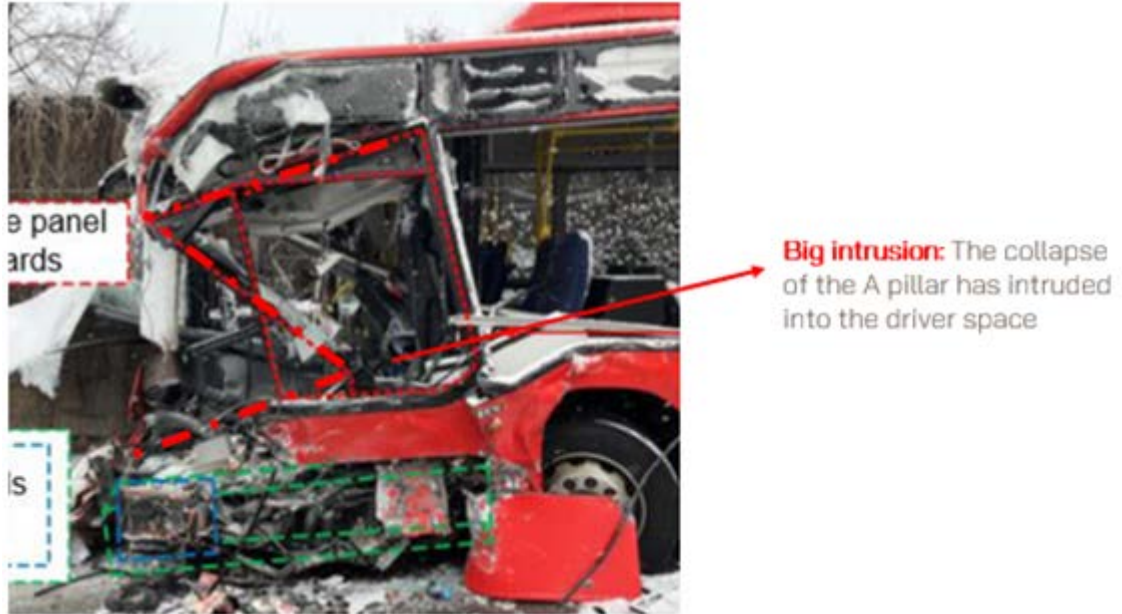
Figure 1.14: Structural status after the crash [3]

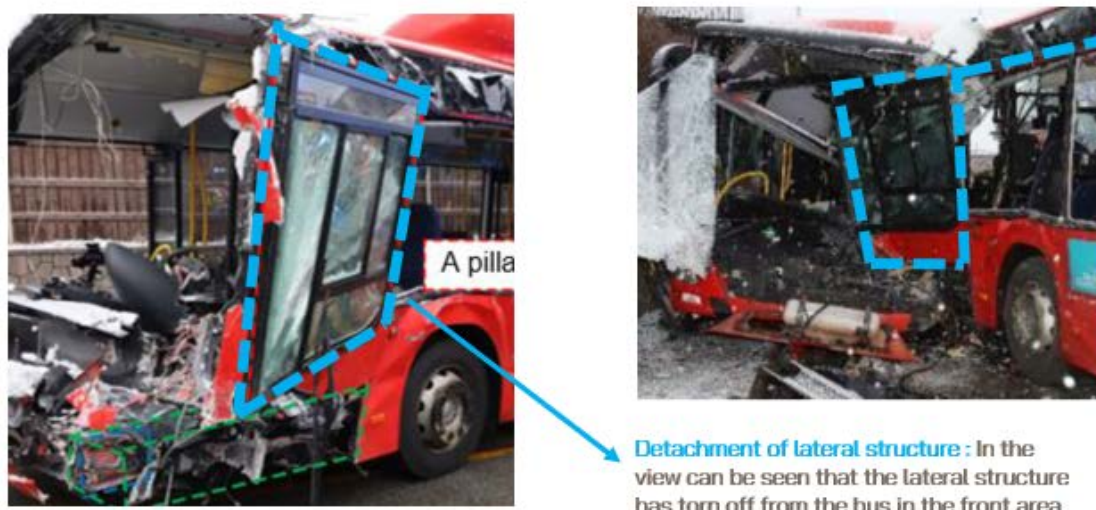
Figure 1.15: Structural status after the crash [3]

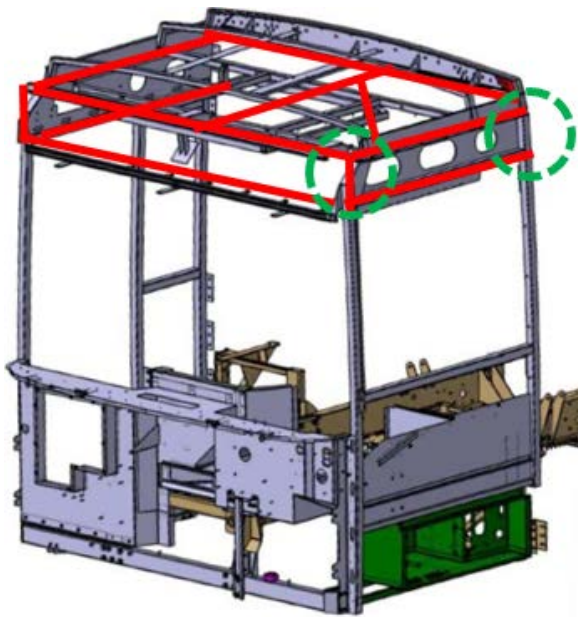
Figure 5.6: View of reinforcement proposal for roof (IDIADA).

Looking at the three discussed Norwegian bus accidents, upper roof connections were detached from the buses' lateral structures. From the accident at Tangen (2021), we could additionally observe that the roof structure was bended down due to the big deformation occurring during the crash. The stiffness of the roof structure and the quality of the connection with the front pillar is assumed to have a big impact in the safety results during the crash. Our recommendation is to increase the strength of the roof connection with the first arch located in the windscreen, and also the connection with the second safety arch, just behind the driver. In addition, the use of reinforcement brackets for the tube connection, and the application of a good weld location strategy, would help to keep the big deformations out from welded areas so the risk of detachment of connections could be reduced significantly.
