TØI rapport 1822/2021

# Performance of automated shuttles at signalized intersections

Video analyses of three intersections in Rådhusgata in Oslo centre

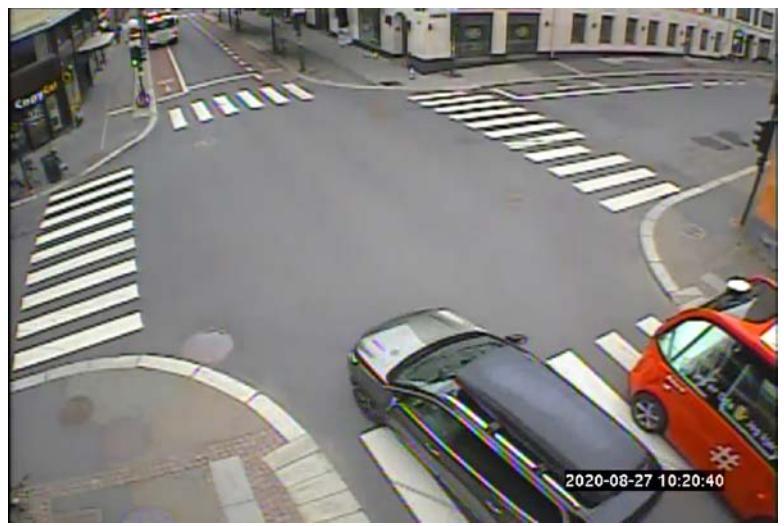
shuttle to stop hard (27/8, 10:20 - see Fig. 7). After that hard stop the shuttle driver probably overtook the driving to continue.

Figure 7 - A car overtaking the shuttle, that stopped hard as a reaction to this maneuver

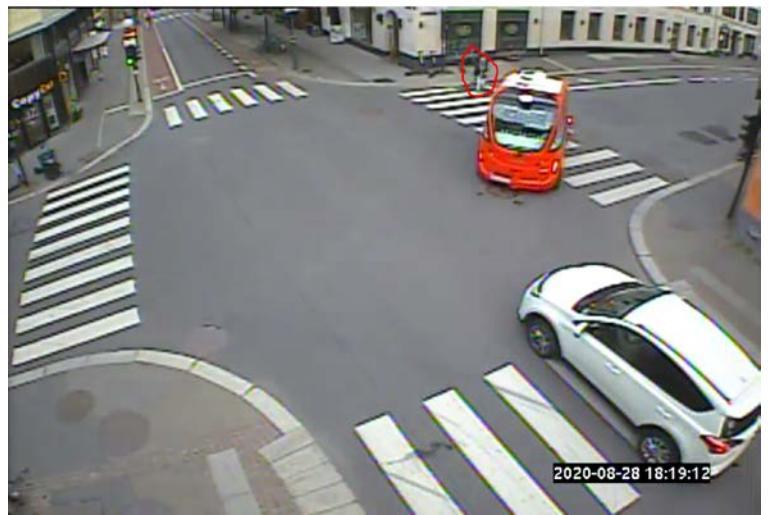
In 13 situations, the shuttle did not give way to pedestrians. In four of them, the intentions of the pedestrians were not clear. Therefore the shuttle slowed down, and then drove first. In four other situations, pedestrians were too far from the crossing. In all these situations the reaction of the shuttle was correct and it drove first. The last five cases where the shuttle did not give way were probably due to the fact that the signals were changing at that exact moment probably because the signals were changing at the time of decision (28/8, 17:12; 29/8, 16:14 and 16:46; 30/8, 19:04) or the pedestrian started crossing outside the zebra crossing (28/8, 17:59 – Fig 8). These situations might be considered incorrect reactions.

Figure 8 – Pedestrians (in red circle) starting to cross slightly outside the zebra crossing, the shuttle drives first

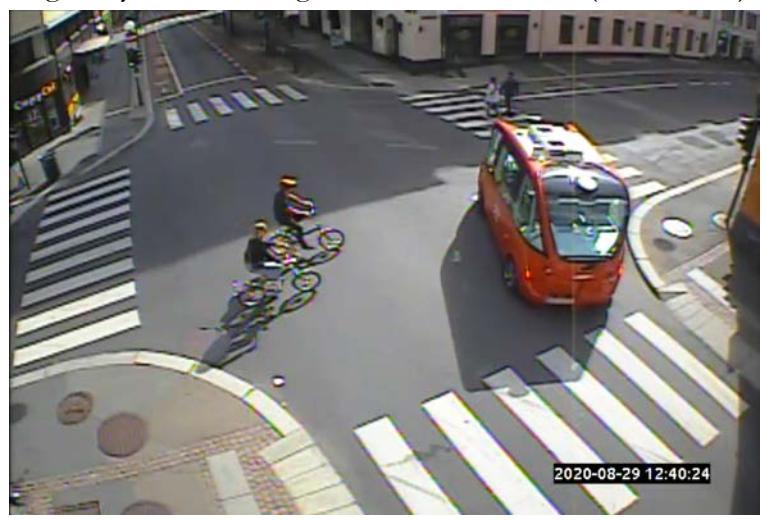
In one situation, the shuttle stopped because there were two cyclists approaching from the left, from Nedre Slottsgate, not stopping for the red signal. The correct reaction would probably have been to continue driving (29/8, 12:40 - Fig. 9).

Figure 9 - Here, the shuttle had to deal with pedestrians crossing the zebra on green light, at the same time as cyclists approached from the left on red signal.

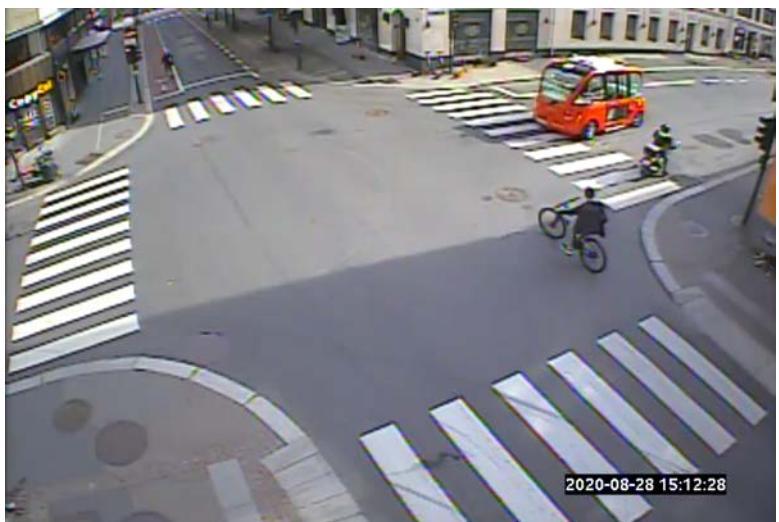
These was a variety of encounters with other road users, involving risky maneuvers from the other road users, such as a van overtaking the shuttle from the left (4/9, 11:13); a scooter overtaking the turning shuttle from the right (28/8, 15:12 – Fig. 10); cyclists approaching from left from Nedre Slottsgate on red signal and trying to overtake the shuttle (29/8, 12:40); or a car driving in Nedre Slottsgate in the opposite direction (27/8, 11:43). The shuttle acted correctly in all these situations – it changed the speed or did not react.

Figure 10 - A scooter overtaking the turning shuttle from its inner side in Zone 4

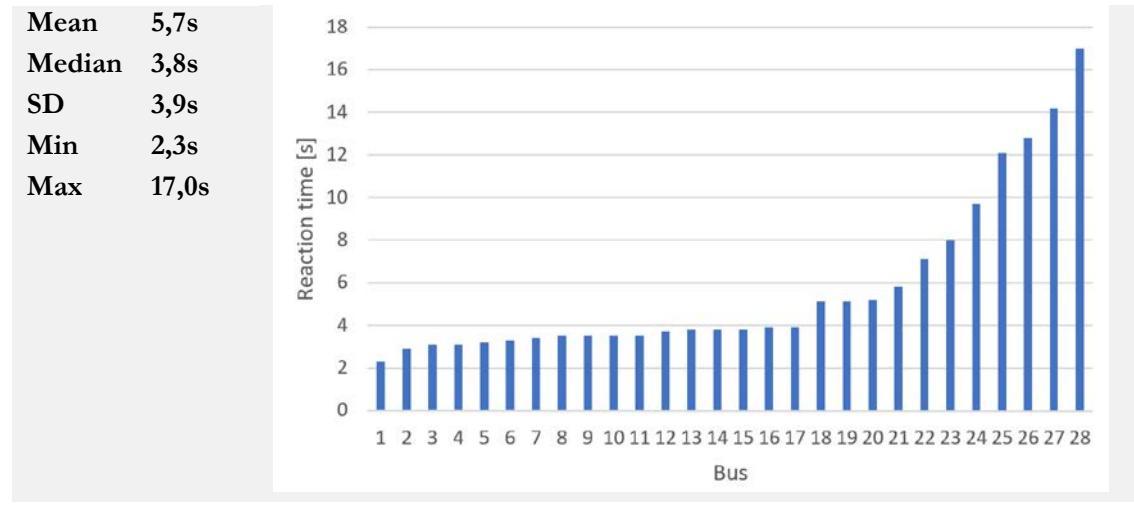
The typical stopping position of the shuttle on the red signal was in the middle of the traffic lane, very close to the stopping line. On several occasions we observed that when both cyclist(s) and the shuttle were waiting for the green signal next to each other, the cyclists let the bus go first on the green signal. In 28 cases it was possible to measure the reaction of the stopped shuttle on the change of the signal from red to green. The mean reaction time was 5.7 seconds (see Fig. 12 for more details).

Figure 12 - The shuttle's reaction times on green signal

The reaction times (>8 s) were very long on several occasions. There might be a connection between reaction time and a hard stop by the shuttle that occurred earlier on the approach.

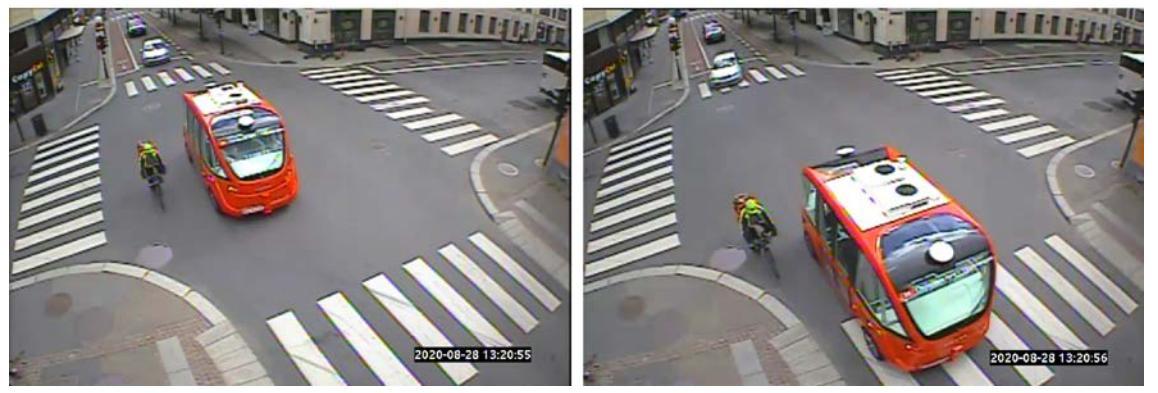
There were four different situations observed in Zone 3. The first one could be characterized as a slight conflict (identified by an evasive action of a cyclist): A cyclist, who rode in the same direction as the shuttle, tried to overtake the shuttle from the right, but had to stop because the shuttle correctly did not react /did not slow down to let the cyclist go first. (28/8, 13:20 – see Fig. 13).

Figure 13 - The conflict situation in Zone 3

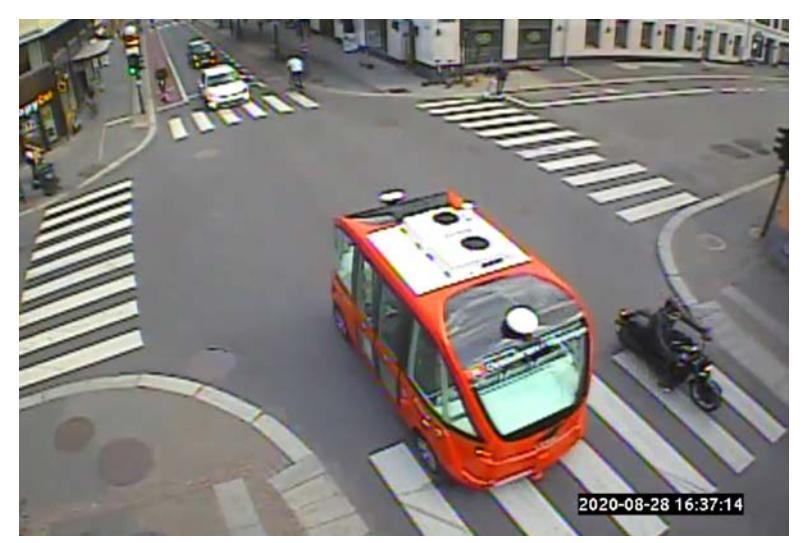
There was only one situation observed in Zone 4, when a motorcycle decided to overtake the shuttle over the zebra crossing. The shuttle did not react to that risky behavior (Fig. 14).

Figure 14 - Motorcycle overtaking the shuttle over the zebra crossing in Zone 4

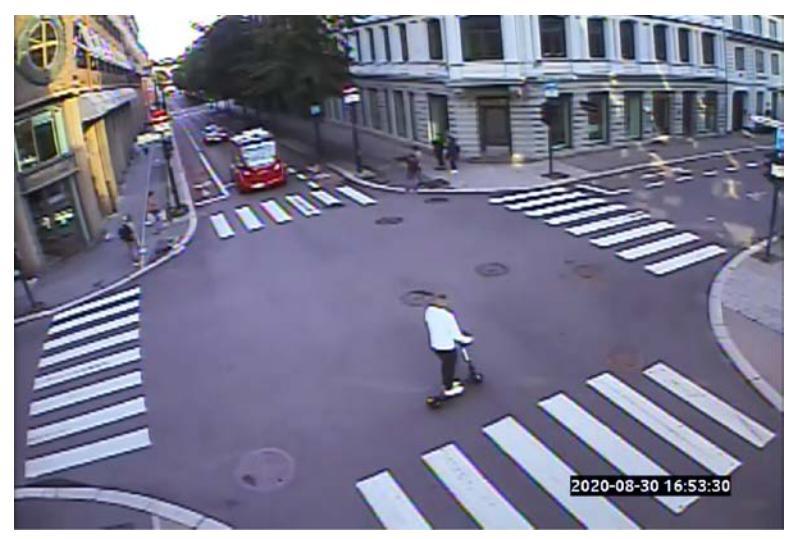
In the one detected situation in zone 2, the shuttle stopped as a reaction to an e-scooterist who was coming from the right on a red light (30/8, 16:53 - see Fig. 16). The shuttle's reaction occurred in the zone 2, even if the el-scooterist was riding far away in zone 3. The reaction was more "preventive" than necessary, there was no obvious risk.

Figure 16 - El-scooterist entering Zone 3 on a red signal triggered the shuttle to stop (the reaction occurred in the position captured on the photo).

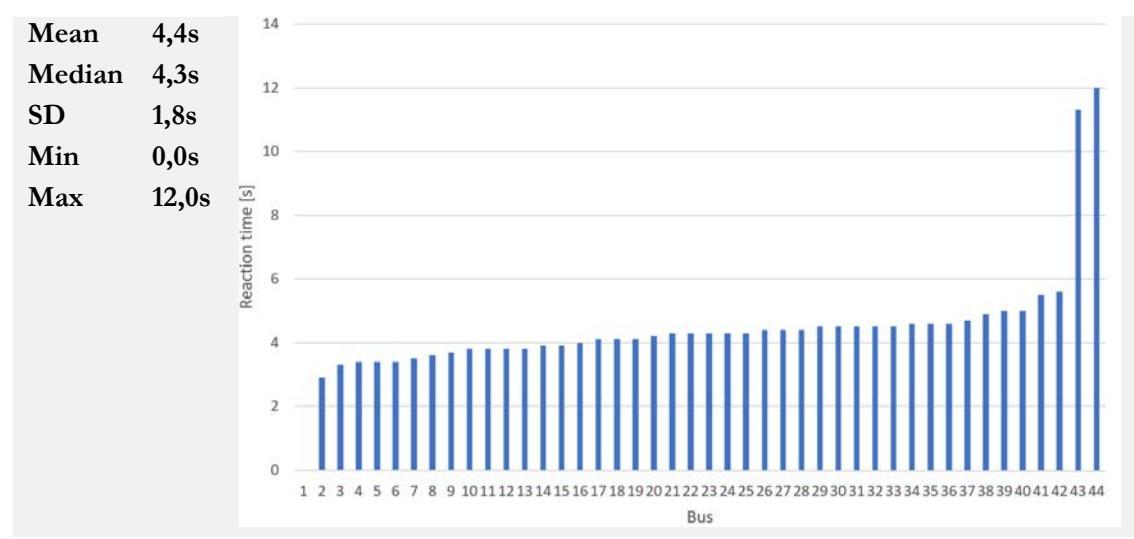
In 33 cases, the shuttle had a green signal, in 42 cases a red signal and in 24 cases there was a signal change (from green to red -9x, from red to green -19x). In the situations with the red signal, all the shuttles stopped on the right side of the street, just at the stopping line. The mean reaction time of the shuttle that was stopped on a red signal when the light turned green, was 4,4s. The reaction time was consistent, with only small standard deviation (see Fig. 18 for more details). There were a few excessively long reaction times, which may be connected with the behaviour of nearby pedestrians or with a hard stop on the approach.

Figure 18 - The reaction times on green signal

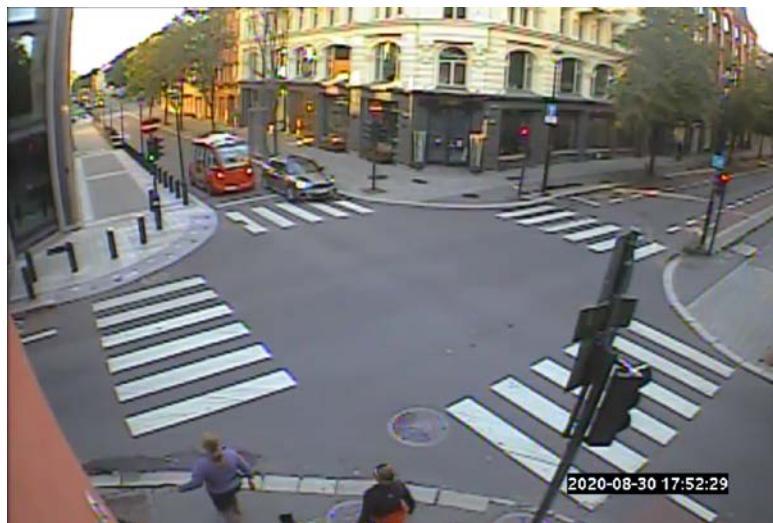
Figure 19 - The car overtaking the shuttle from the left in Zone 1-2

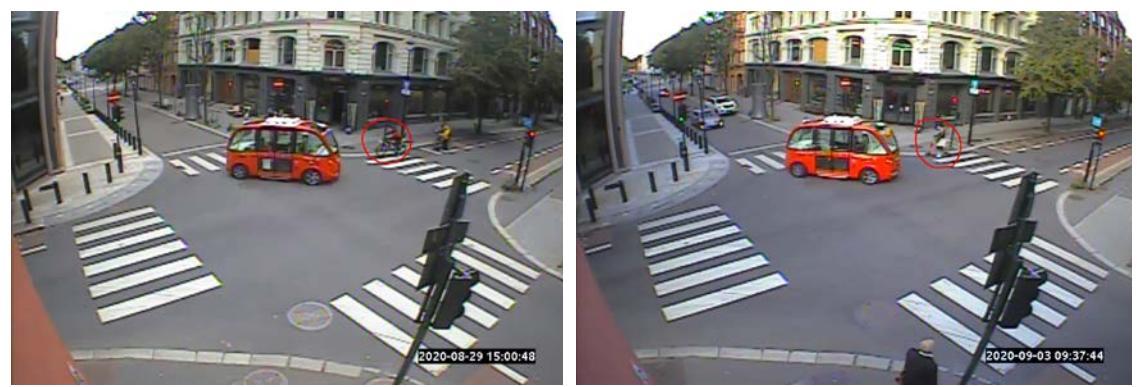
In 11 situations, the shuttle's reactions to other road users were not correct. The shuttle typically stopped in the middle of its left-turning manoeuver, because there were either a pedestrian standing nearby the crossing, a pedestrian who had already crossed, or there were cyclists waiting on the approach (in direction from Christiania Torv), placed inside the intersections (Fig. 20). These stops resulted in situations where the shuttle stayed "locked" inside the intersection even after the change of signals (in one case for 2:30 min – 4/9, 11:37) causing the other road users to drive around the shuttle (Fig. 21). Typically, the shuttle driver had to take over the driving and move the shuttle out of the intersection.

Figure 20 - The positions of the waiting cyclists, that triggered several reactions by the shuttle in Zone 3

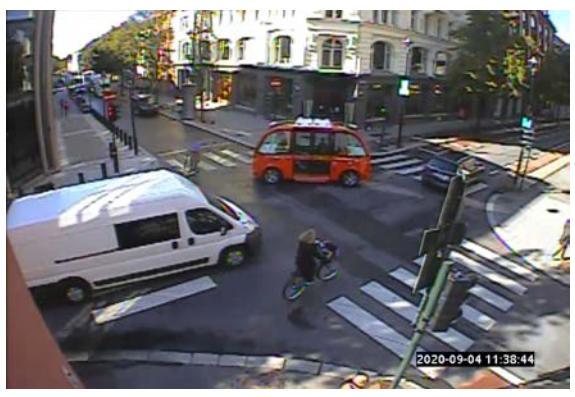
Figure 21 - The shuttle stayed inside the intersection after an unnecessary stop in Zone 3
