Summary:

Extended road shoulders on rural roads: A measure for cyclists and pedestrians?

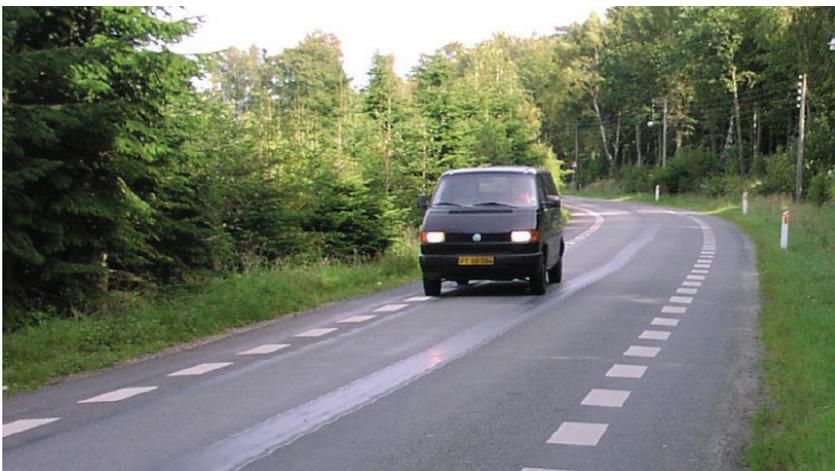
The present study summarizes results from evaluation studies of extended road shoulder and similar measures and it is estimated what effects may be expected in Norway on rural roads with a speed limit of 60 km/h or lower. A 2-minus-1-road is shown in figure S.1.

Figur S.1: 2-minus-1-road (Helsingør Kommune 2006).

2-minus-1-roads with extended road shoulders and removed centre line aim at improving cycling and walking conditions along low traffic rural roads. They provide more space to vulnerable road users. The number of driving lanes is reduced from 2 to 1. The measure is currently not used in Norway. Experience from other countries has shown that 2-minus-1-roads do not lead to the expected speed reductions, and that overtaking vehicles keep less distance to cyclists because cyclists cycle further away from the edge of the road than on roads without extended shoulder. There is also confusion among road users as to what rules apply on 2-minus-1-roads. Problems may also arise from sand, gravel or parking cars in the road shoulder. If extended shoulders are to be used in Norway, it is recommended that additional measures are implemented, or alternative measures that are less easy to misunderstand.

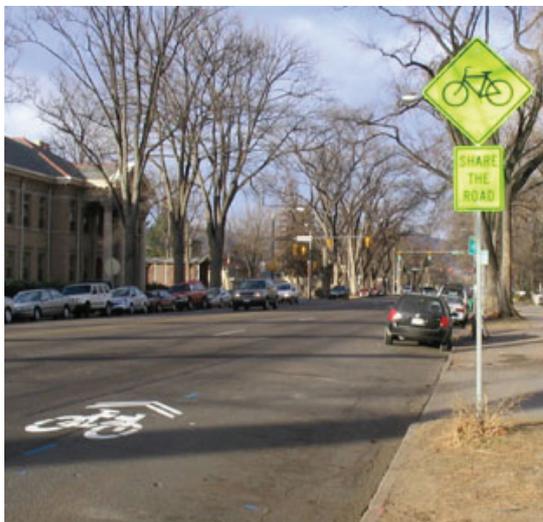
An alternative measure which has the same aim as 2-minus-1-roads, but a different design are “bike and chevron” road markings. An example is shown in Figure S.2. Bike and chevron symbols are marked on the right side of the road, indicating that cyclists are supposed to use the road, without suggesting that the right part of the driving lane might be reserved for cyclists. In Belgium and San Francisco it was found that this type of road marking has positive effects on driver and cyclist behaviour and reduces conflicts.

Figur S.2: "Bike and Chevron" in San Francisco (fcgov.com Transportation Planning).
