Crashworthiness of buses

Analysis of European data and suggestions for improvements

2082/2025

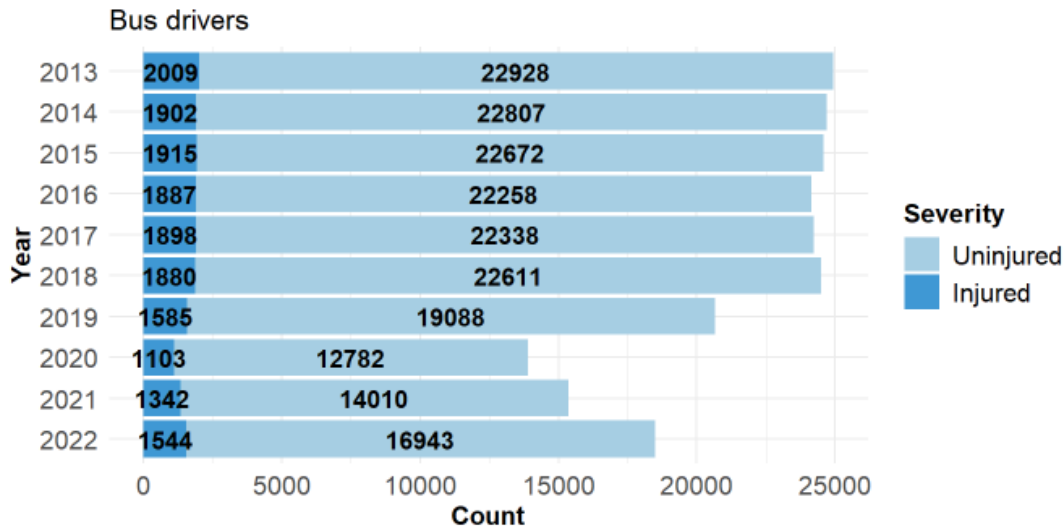
Figure 3.1: Bus drivers registered in the CARE database.

Figure 3.1 displays the number of bus drivers in the CARE database, for all countries. The figure illustrates clearly why the interpretation of trends over time is not straightforward with this material. The drop from 2018 to 2019 is due to the UK only being included up until 2018. The increase from 2020 to later years cannot be explained with additional countries joining the database. However, in some countries, there were quite large increases in the numbers of injured bus drivers in these years (Germany, Italy, Poland, Spain). This may be a real increase related to a drop in accidents (and driving) during the Covid-years, especially in 2020.

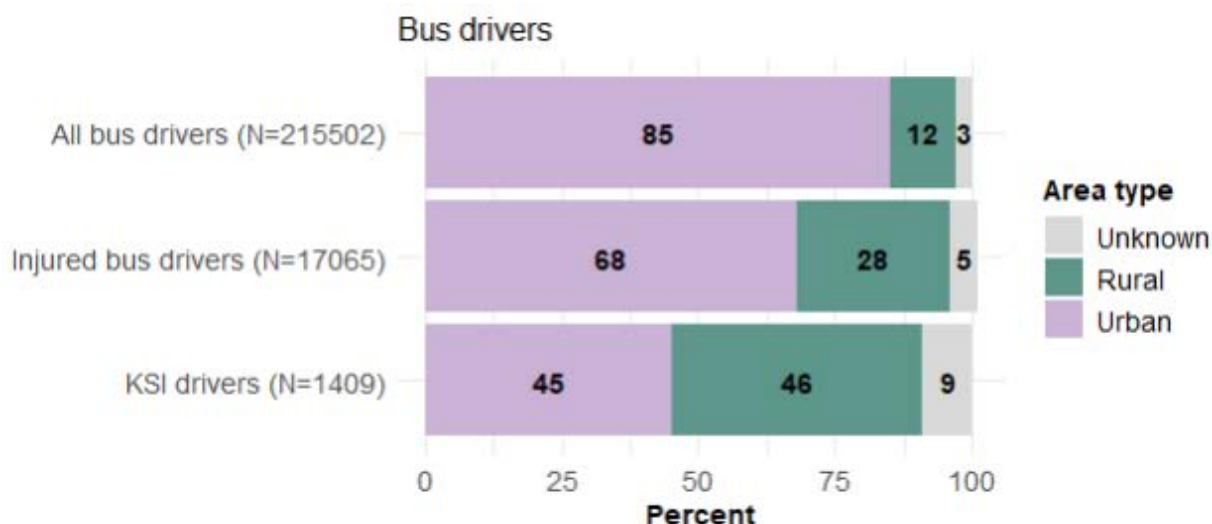
Figure 3.4: Area type of accidents by bus drivers' injury severity. CARE database.

When we look at all accidents jointly, most occur in urban areas (85 %, Figure 3.4). However, for bus drivers who are injured, or who are killed or severely injured, rural areas make up a far larger share of accident sites. This is likely related to speed at the time of the accidents; the speed is probably higher on rural roads than in urban areas, and accidents at higher speeds are on average more serious.

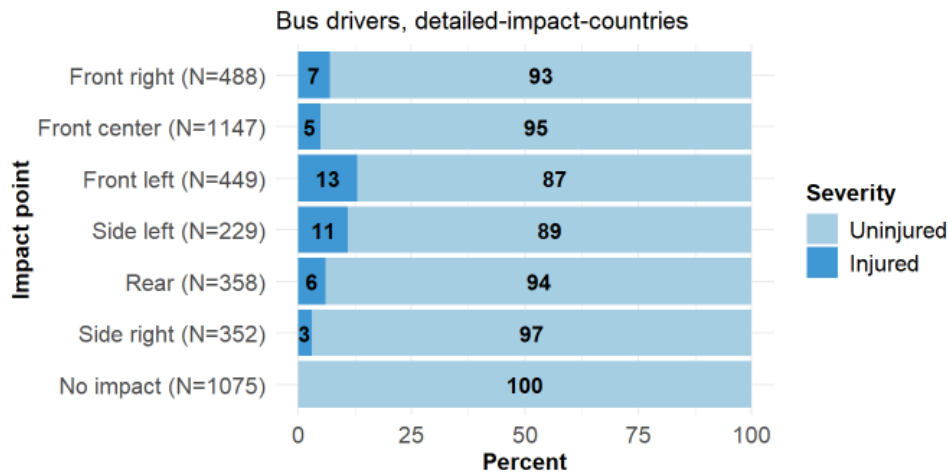
Figure 3.7: Injury risk for bus drivers by impact point in head-on collisions. Results from 3 European countries with detailed impact points, CARE database.

Results for detailed impact points are displayed in Figure 3.7 (bus driver injury risk) and in Figure 3.8 (bus driver injury severity). The figures show that the front left and side left impact points are associated with a higher risk of injury and more serious injuries than other impact points.

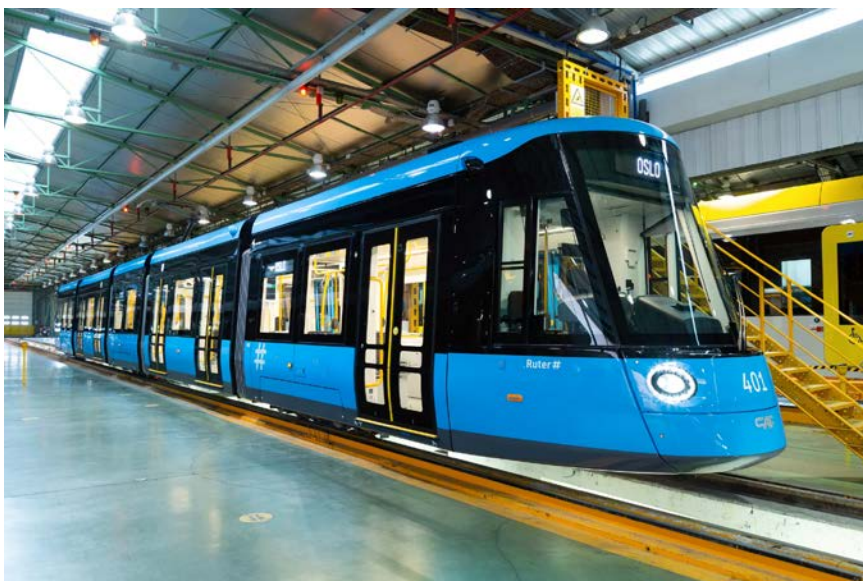
Figure 5.3. Front design of new trams introduced in Oslo 2022-2024

Martin et al. (2020) found that a rounded bus front reduced the number of pedestrians who were run over by buses. In this context, the front of the bus was only slightly rounded and slightly backward leaning. It seems logical that a better protection of the driver can be attained by adopting the more extreme version of front design shown in Figure 5.3.

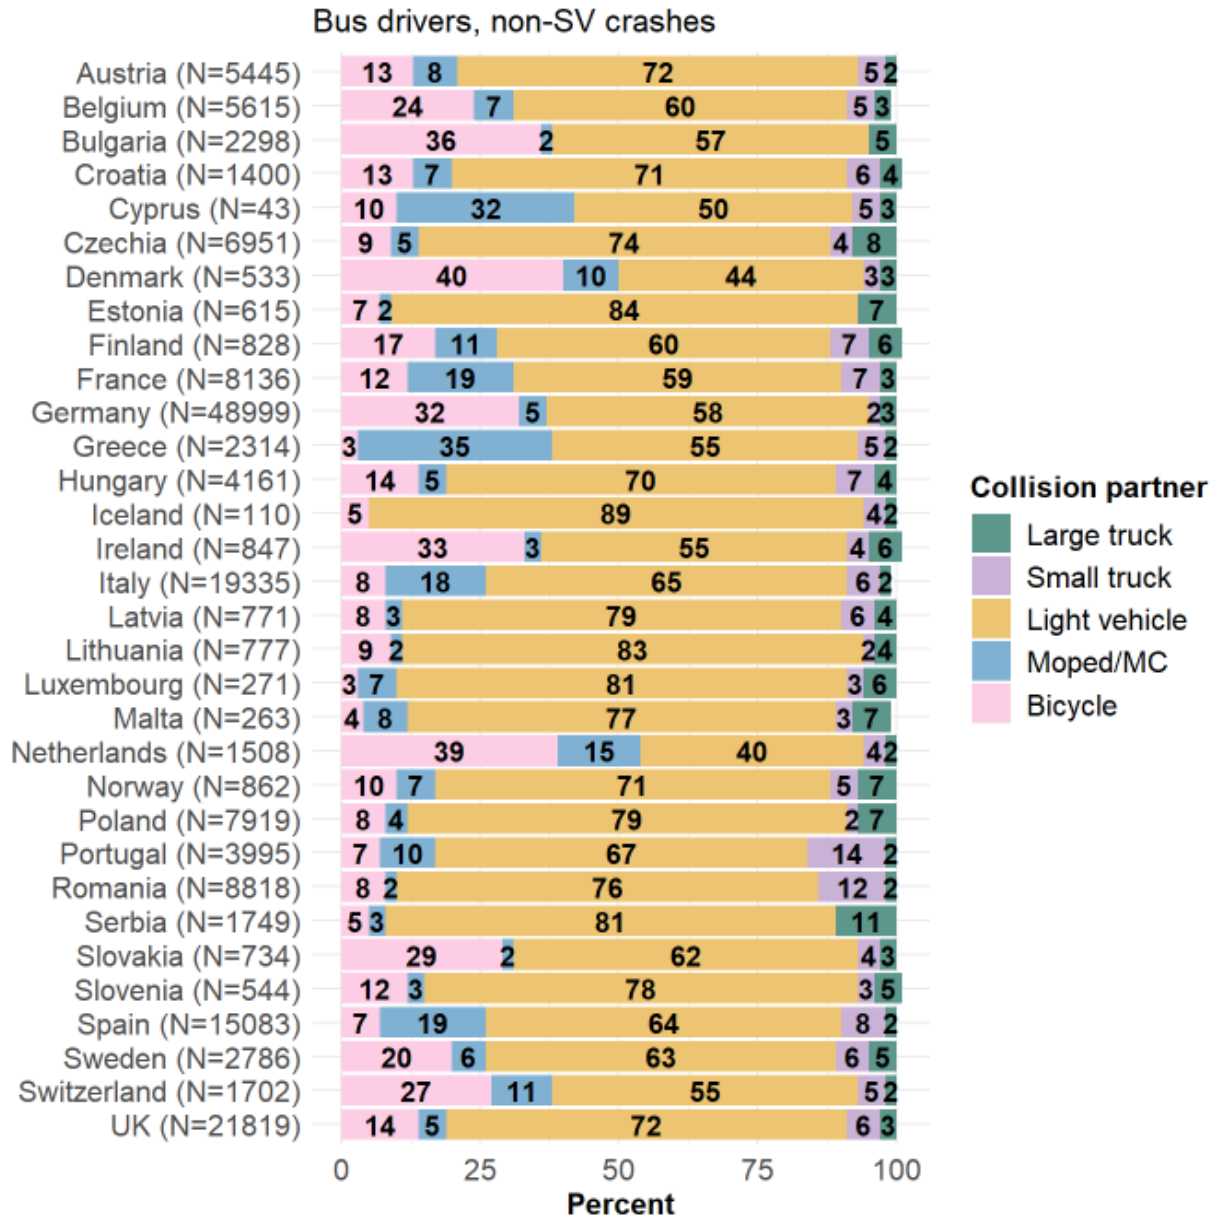
The following figure shows the distribution of the inferred collision partners for all bus drivers in non-SV crashes for each country. The distributions look reasonable; most potential collision partners are light vehicles, and countries with a lot of bicycle traffic, especially the Netherlands, have many cyclists as potential collision partners.
