TØI rapport 1822/2021

# Performance of automated shuttles at signalized intersections

Video analyses of three intersections in Rådhusgata in Oslo centre

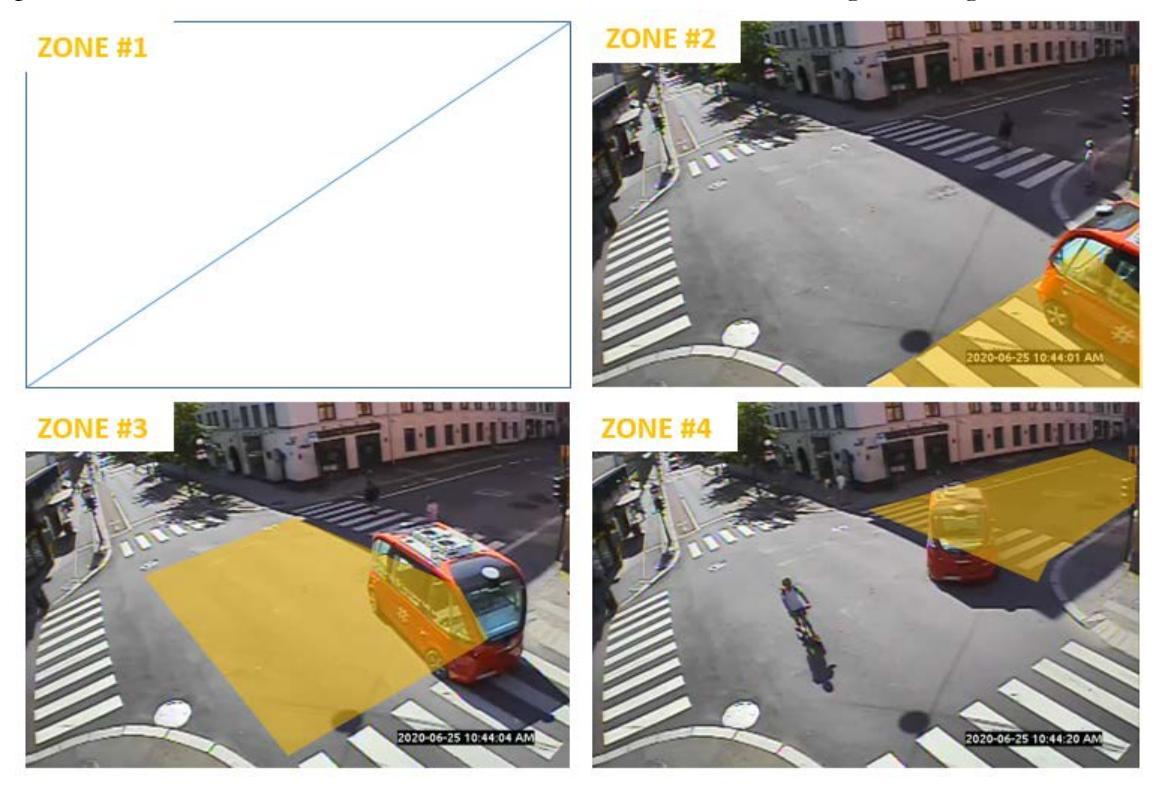
Figure 6 - Three visible zones at the intersection A1

There were in total 106 right-turning shuttles recorded in Nedre Slottsgate. As can be seen from Figure 6, the camera did not cover zone #1 (approach along Rådhusgata from Christiania Torv) and a part of zone #2 (part of zebra crossing on Rådhusgata). The signal phase was recognizable from the traffic light in the upper left corner of the recording. However, the stopping line on the approach was not visible and therefore it was not possible to measure the reaction time of the shuttle on the traffic signal change.

In 49 of the cases, the manoeuvre of the shuttle was smooth and the bus did not experience any encounters. In the remaining 57 cases, there were 70 situations detected.

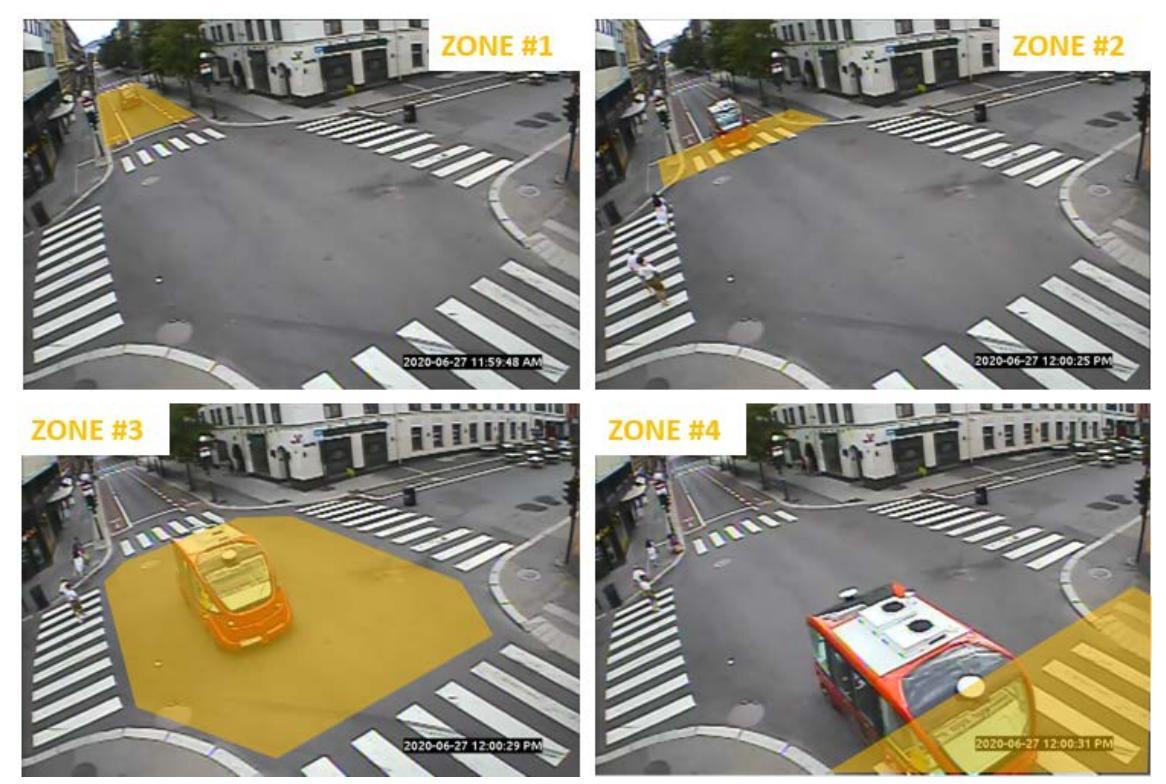
Figure 11 - Four zones at the intersection A2.

In total there were 102 straight going buses recorded in the route along Rådhusgata towards Christiania Torv. There were in total 35 situations detected in A2. Most of them were observed in zone #1.

As can be seen from Figure 11, the camera did not fully cover zone #4 (exit from the intersection). The signal phase was recognizable from the traffic light in the upper left corner of the recording.

The typical stopping position of the shuttle on the red signal was in the middle of the traffic lane, very close to the stopping line. On several occasions we observed that when both cyclist(s) and the shuttle were waiting for the green signal next to each other, the cyclists let the bus go first on the green signal. In 28 cases it was possible to measure the reaction of the stopped shuttle on the change of the signal from red to green. The mean reaction time was 5.7 seconds (see Fig. 12 for more details).

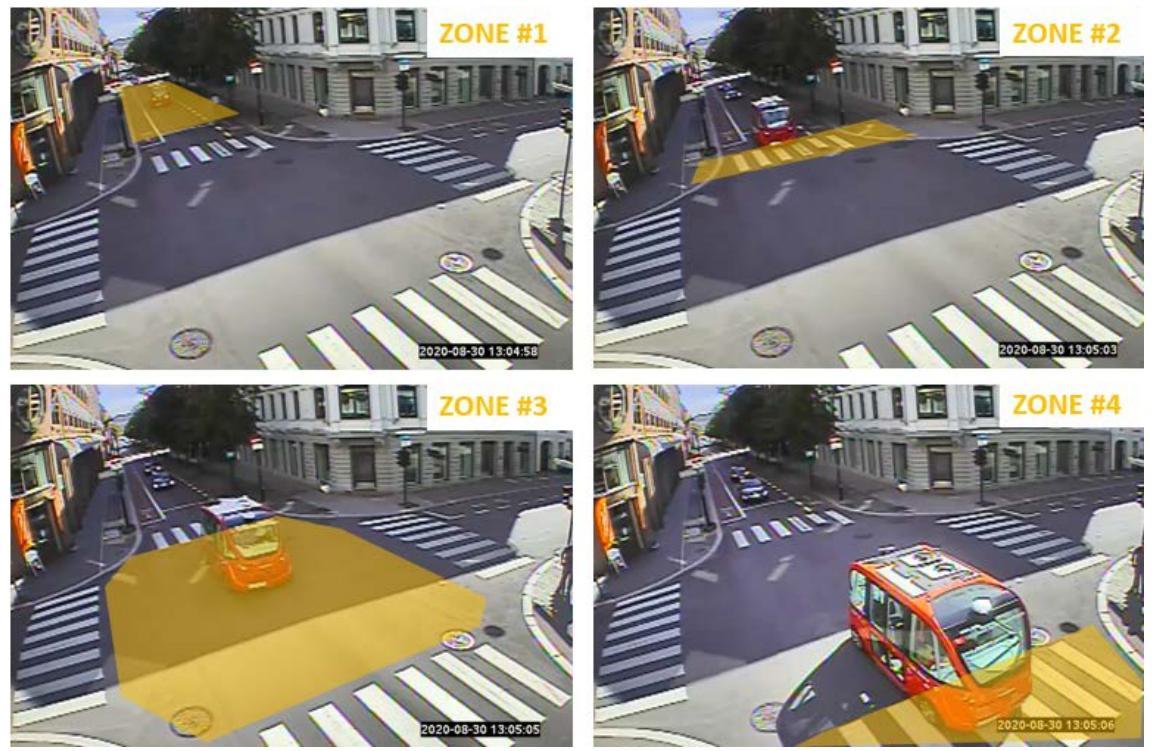
Figure 15 - Four zones at the intersection B

In the Rådhusgate/Kongens gate intersection, a total of 104 shuttles were recorded. As mentioned previously, the signal phase on the approach was not recognizable from the video. Therefore, it was not possible to measure the shuttle's reaction time on traffic signal change. The stopping positions of the shuttle on red signal were consistent. The shuttle typically stopped in the middle of the traffic lane, very close/tight to the stopping line.

There were 12 situations identified, the majority of them occurring in zone #1.

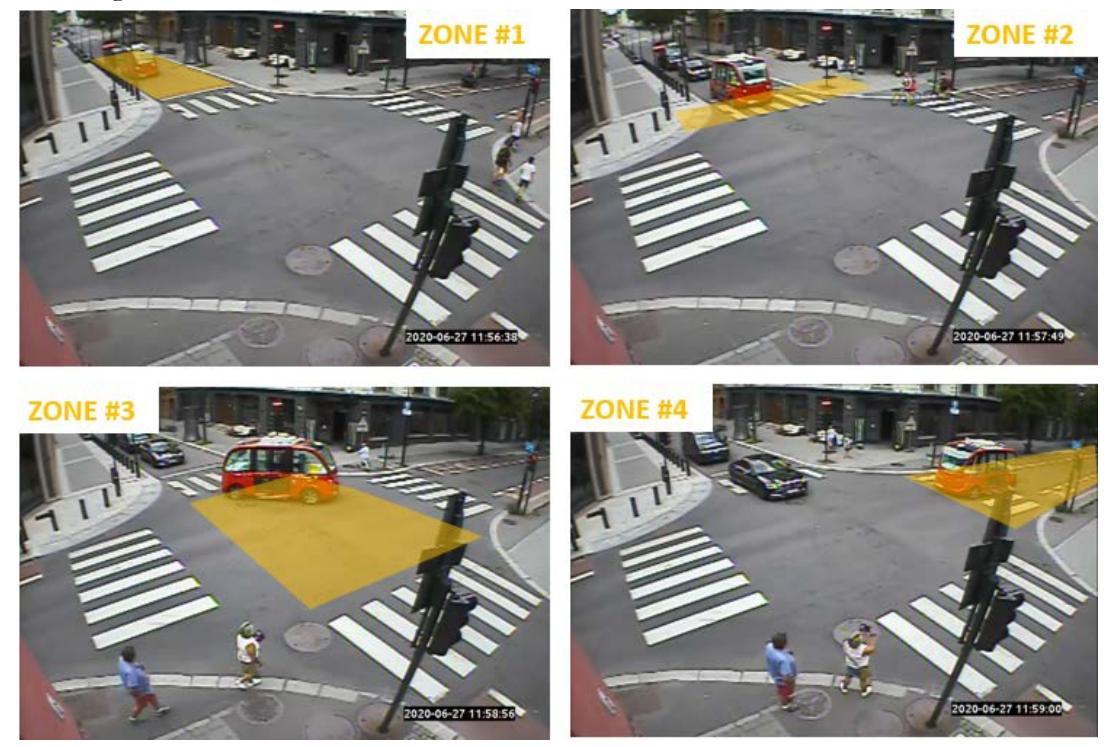
Figure 17 - Four zones at the intersection C

In 33 cases, the shuttle had a green signal, in 42 cases a red signal and in 24 cases there was a signal change (from green to red -9x, from red to green -19x). In the situations with the red signal, all the shuttles stopped on the right side of the street, just at the stopping line. The mean reaction time of the shuttle that was stopped on a red signal when the light turned green, was 4,4s. The reaction time was consistent, with only small standard deviation (see Fig. 18 for more details). There were a few excessively long reaction times, which may be connected with the behaviour of nearby pedestrians or with a hard stop on the approach.

Four situations were observed 10–50m from the stopping line, when the shuttle was reacting to cars that were parked along the left side (from the shuttle's perspective) of the street. In all these situations, the shuttle made an unnecessary stop and at least twice it seemed that the shuttle driver had to take over the driving, so the shuttle could continue.

There were three situations observed in Zone 2. In two of them, the shuttle's reaction was not correct – a delayed hard stop, probably as a reaction to an e-scooterist overtaking from the left (28/8, 17:53), and a hard stop without any obvious reason (30/8, 12:09). In the third situation the shuttle reacted correctly, as it stopped when several e-scooterists rode towards the shuttle (29/8, 14:42).

Almost all situations were observed in the two intersections, where the shuttle was making a turning maneuver (left or right). In intersection C, 11 situations were observed when the shuttle stopped in the middle of its left-turning maneuver. These unnecessary stops were triggered by either a pedestrian standing near the crossing, a pedestrian that had already crossed or there were cyclists waiting on the approach (in direction from Christiania Torv), placed in an untypical position. This might suggest some issue with the detection in the left front area of the shuttle. These incorrect stops resulted in situations when the shuttle stayed "locked" inside the intersection even after the change of signal, creating an obstacle to other road users. Typically, the shuttle driver had to take over the driving and move the shuttle out of the intersection.
