Technical Study of collision protection for bus drivers

Development of new solution trends for collision
protection

Manuel Laso, Tor-Olav Nævestad

2096/2025

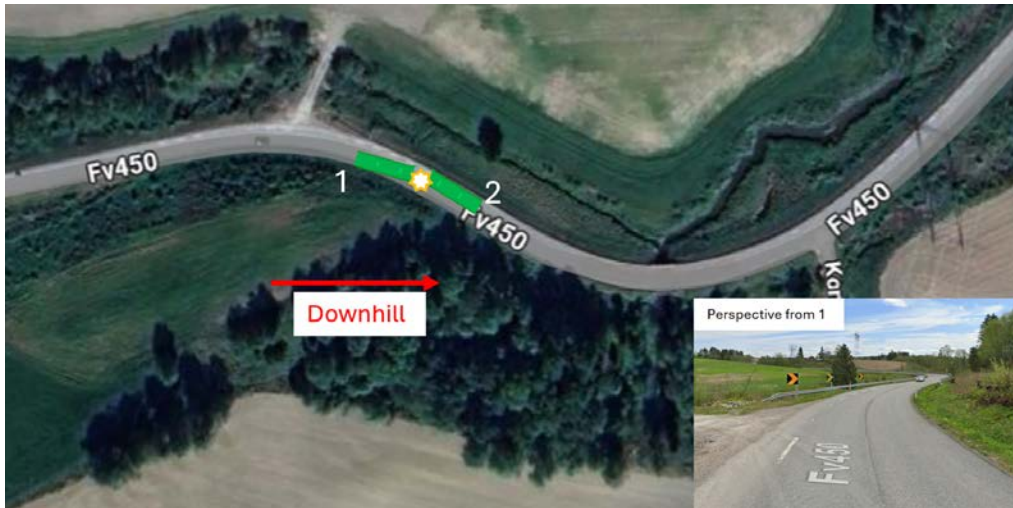
Figure 1.1: Nafstad accident location. Layout of the accident [1]

Despite the slight curve in the road, this can be considered a fully frontal collision with an overlap of approximately 1 meter, which is 39.21% of the bus's total width of 2.55 meters. The impact speed was around 34 km/h after the braking systems of both buses were activated. Although the buses

were traveling at relatively low speeds of 33-34 km/h, the collision caused significant deformation to both vehicles. The eastbound bus driver tragically lost his life on the spot, while the westbound driver suffered severe injuries after being trapped by the structures of the colliding bus.

Driver deceased (intrusion of structure)

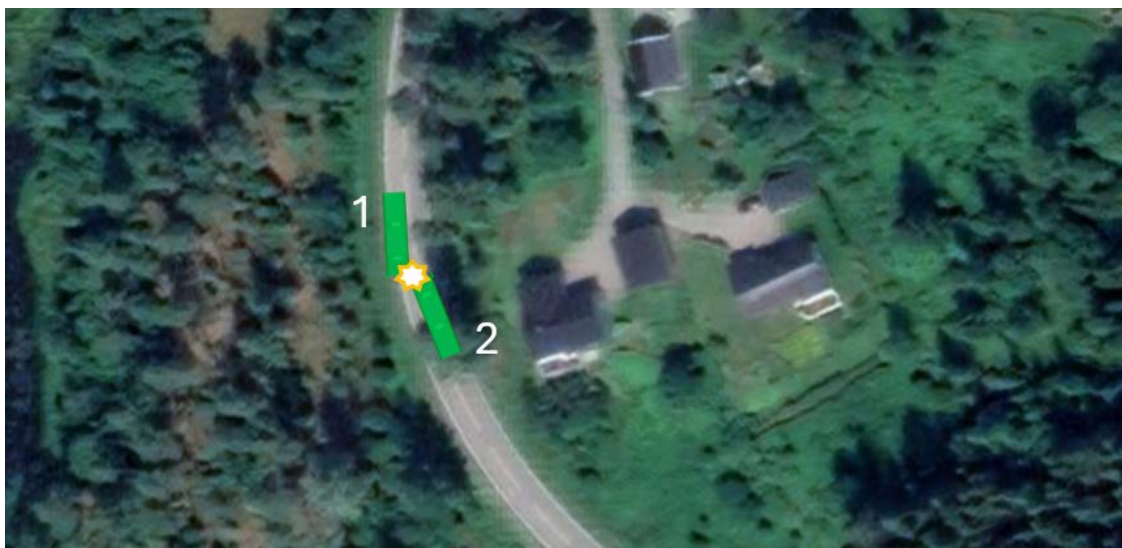
Figure 1.3: Tangen accident location. Layout of the accident [2]

The limited visibility in the curve did not help to prevent the accident. As a result, the southbound bus collided at an approximate speed of 27 km/h, while the northbound bus crashed at 42 km/h after both drivers applied the brakes. The impact was primarily frontal, affecting the leftmost edge of both vehicles, with an impacted area estimated between 150-200 mm, which translates to an overlap of about 5% to 8%. The result of the impact conducted the decease of the driver of the southbound bus, whilst the other driver was slightly injured.

The collision primarily involved the left front corners of both buses, causing significant structural damage, particularly in the driver's cabin area. The A-pillar of the northbound bus intruded into the driver's compartment of the other bus, resulting in fatal injuries for the southbound bus driver despite the relatively low speeds. The central section of the vehicles was almost entirely uninvolved in the impact, meaning that all the collision energy was concentrated on the A-pillar of the first arc. As in previous cases, one structure was torn and penetrated, while the other collapsed inward. However, in this instance, the minor overlap allowed the vehicles to keep moving forward.

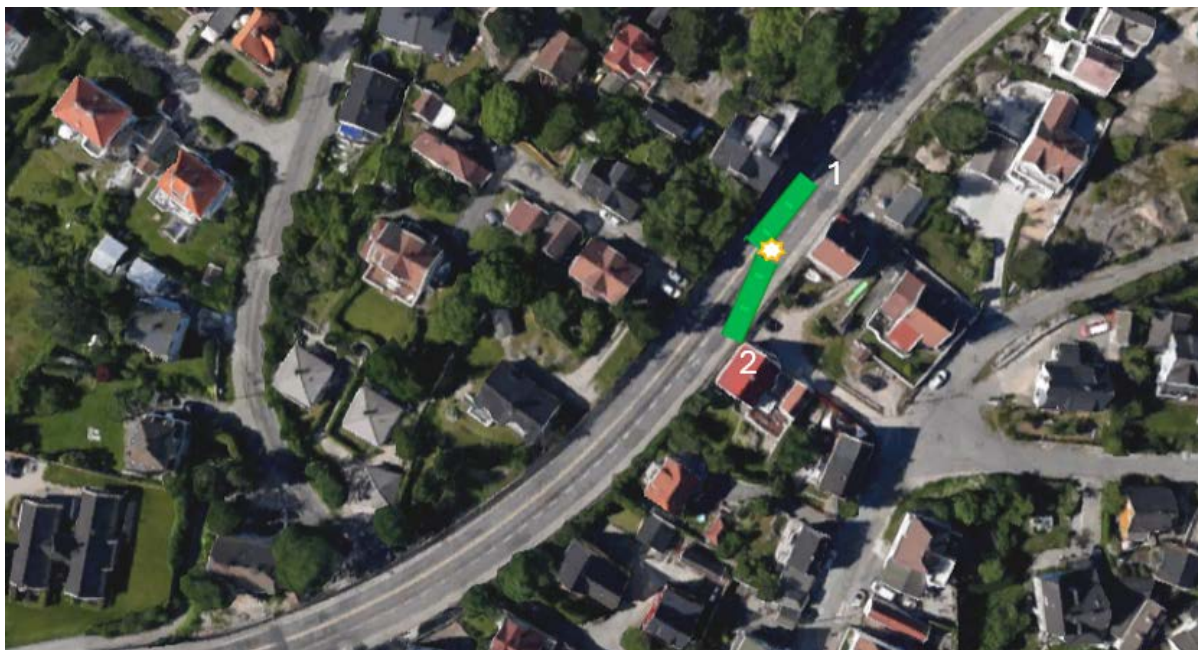
Figure 1.5: Fredrikstad accident location. Layout of the accident [3]

According to tachograph records, the bus coming from the south impacted at an approximate speed of 32 km/h, while the one approaching from the northeast collided at a speed of 40 km/h. The exact cause of why one of the drivers veered into the opposite lane, leading to the collision, remains unknown. The report from the Norwegian authorities does not specify the overlap involved in the crash. However, an analysis of the images suggests that the impact was intermediate between the incidents accidents in 2017 and 2021, with an overlap estimated to be less than 1 meter on the leftmost side of the vehicles.

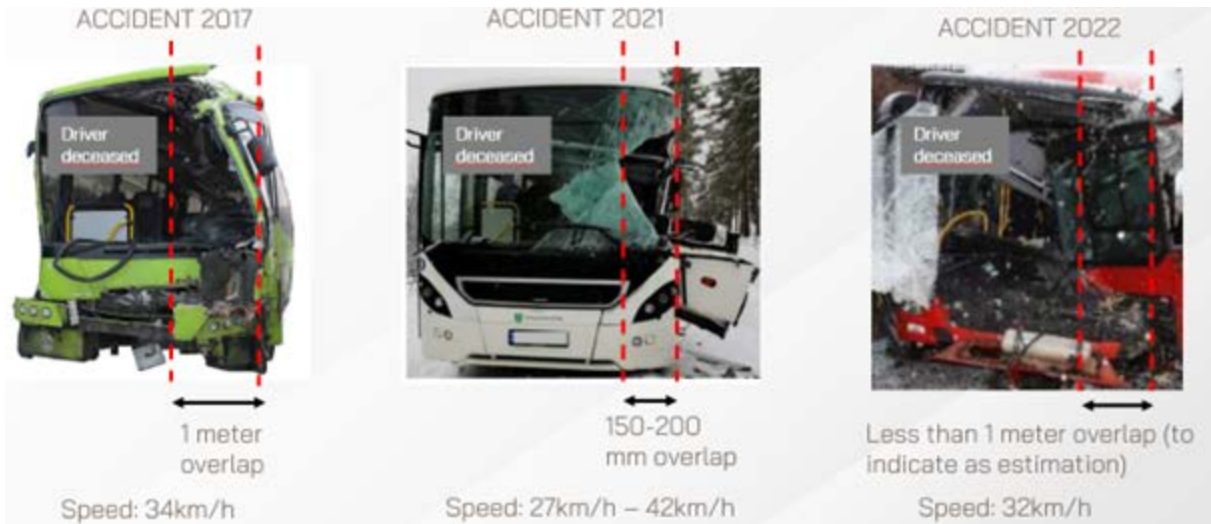
Figure 1.7: Crash overlap in the three different accidents.

These accidents highlight a worrying trend where bus structures, particularly in the front corners and A-pillars, are not designed to face frontal collisions with small overlap. Despite the introduction of new regulations in Norway requiring frontal impact tests, these do not address the structural weaknesses observed in the aforementioned accidents. Current safety standards must be updated to include resistance testing for partial side impacts and to enhance protection in driver cabins.

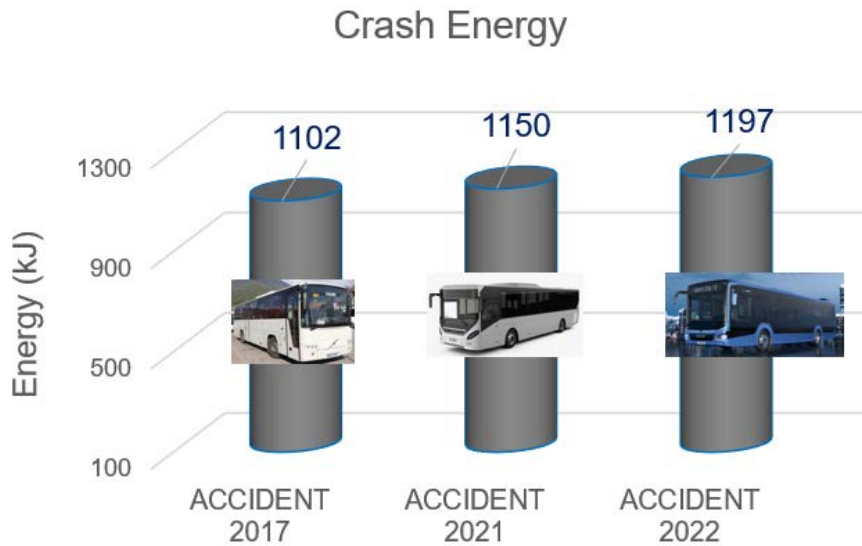
Figure 1.16: Crash energy produced in the 3 accidents.

In the 3 accidents, the final crash speed between both buses is assumed to be 7.2 km/h (2 m/s). In addition, the mass ratio between buses is approximately 1, meaning that each bus absorbs half of the total amount of energy produced in the crash.

The level of energy produced in these three accident scenarios can be considered equivalent, considering the boundary conditions of all buses, summarized in the next image. The level is about 10 times the energy tolerance values prescribed in Regulation UN R29.03.
