# Unmarked crosswalks – Traffic safety and universal design

TØI Report 1743/2019

Authors: Alena Katharina Høye, Siri H. Berge, Kjersti V. Øksenholt & Katrine Karlsen  
Oslo 2019 118 pages Norwegian language

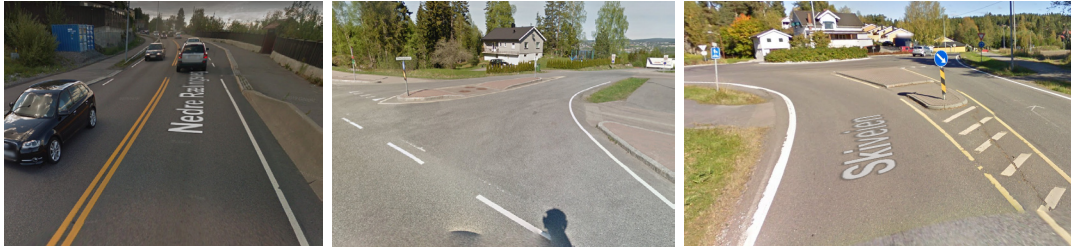
The reason for having unmarked crosswalks is to improve mobility for crossing pedestrians and to channel them such that they cross the road at the same location. Improved traffic safety is not one of the aims of unmarked crosswalks, but they should in any case not increase the accident risk. Some examples of unmarked crosswalks are shown in Figure S.1. More examples can be found in Appendices 1, 2 and 3.

Figure S.1: Examples of unmarked crosswalks.
